**Chevy Chase Village
Board of Managers**

- **Continuance of A-6895 (Appeal of the Manager's Decision)**

Appeal of the Manager's issuance of Building Permit #6879 (to Mr. David J. & Ms. Megan L. Rose of 5502 Grove Street) to construct a fence measuring six feet, six inches (6'-6") in height and a retaining wall measuring a maximum of three (3) feet in height abutting their rear property line. *This case was introduced at the Village Board's March 14 meeting.*

**Report from the Twinn's Engineer in Response to
the October 14 OIP+A Report**

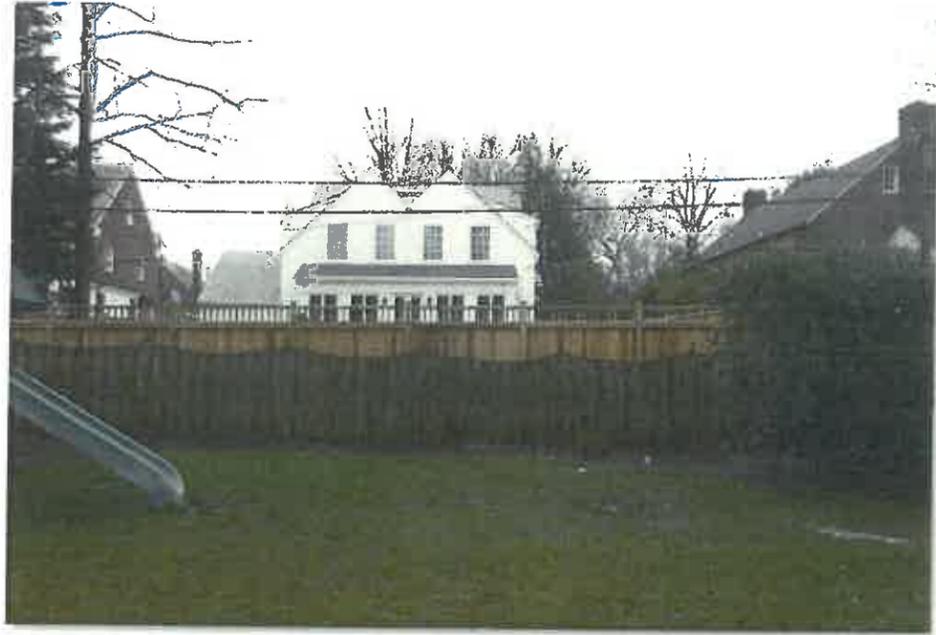
Figure 1: Looking south from 5503 Center Street at the new fence installed at 5502 Grove Street.

- A **retaining wall** mostly in the limits of Lot 29 and Lot 27, as can be seen in figure 1. The wall is made of wood strips with a little hole every 4 feet, approximately, as drainage system (photo #4 in figure 1). Regarding the Lot 29, the wall ends around 6 feet before the property limits in the corner with Lot 30.
- A **soil filling** to grade the yard and get a horizontal land surface in their yard
- A **fence** around the backyard on the new land level and
- A **storm water storage chamber connected to the roof gutters** and a popup emitter that smoothly allows water out and disperses it through the back yard.

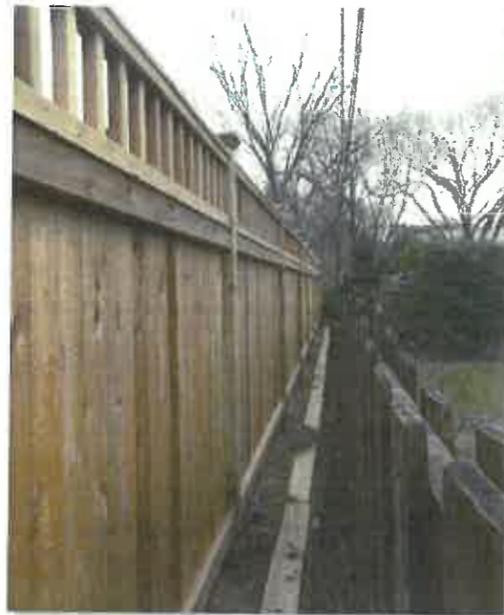
Figure 2: Looking south showing the fence at 5503 Center Street (on the right), and the new retaining wall and fence at 5502 Grove Street (on the left).

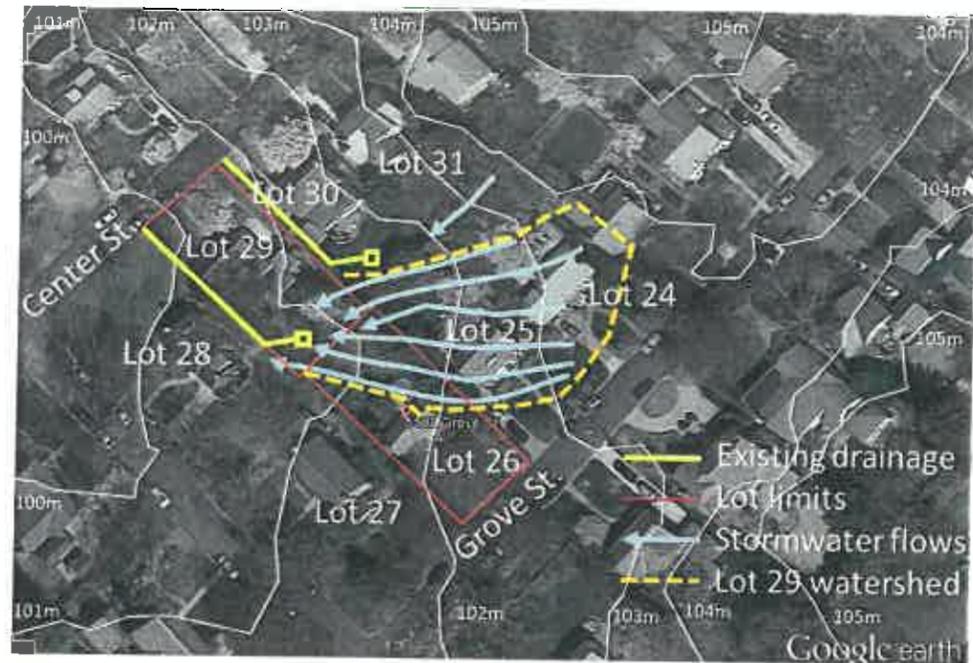
Figure 4: Contour lines and watershed limits before the grading

The **watershed** of Lot 29 has been defined here as the area where the water comes from when it rains. Its limits have been obtained by combining different criteria: (i) drawing its limits where slopes change from negative to positive or vice versa, (ii) drainage systems that cut a surface water flow (like in Lot 30) and (iii) drawing perpendiculars to contour lines. Figures 2 and 3 show longitudinal profiles and figures 4 and 6 show contour lines to define the watershed (before and after the grading). The watershed area defines the amount of water that goes to the backyard of Lot 29 when it rains depending on the precipitation rate. Obviously, the bigger the watershed is the greater amount of water it will receive.

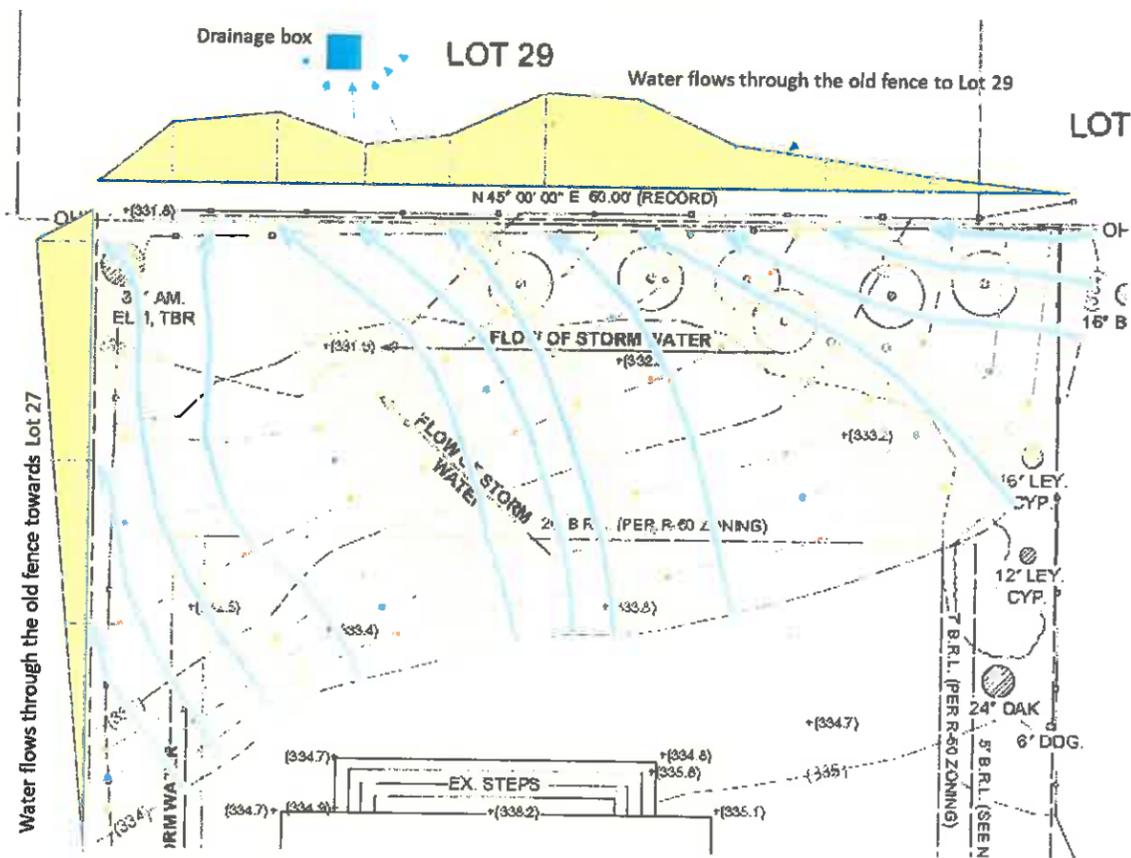
Figure 5: water flows in Lot 26 before grading

The **water flows** are the paths the surface water follows according to the land profile when it flows by the steepest downwards slope (perpendicularly to the contour lines). The water flows define how the water from the watershed enters the back yard of Lot 29. See figure 5 for details on how water used to flow from Lot 26 towards Lot 29. For this purposes, additional contour lines have been interpolated based on the information of the original proposal.

At the request of Chevy Chase Village, we briefly reviewed the report prepared by the neighbor's engineer. Figures 5, 6 and 7 appear to give an accurate description of the changes in water flows caused by the grading on the subject property that have adversely impacted the neighboring lots. We also agree with the report's finding that a sufficient drainage system has to exist behind the retaining wall to convey the runoff through the retaining wall. The contractor has stated that such a system was installed for this project.

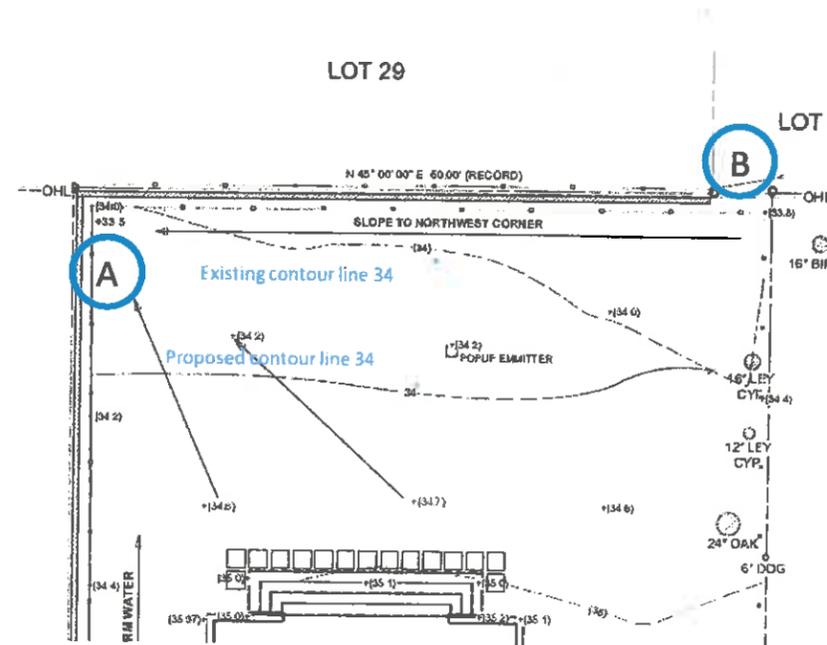
Figure 8: Proposal from the owners of Lot 26

Unfortunately, the solution described in the drawing (figure 8) provided by the advisor to the Roses does not have enough information to judge it. It might be because of some missing pages or because there is a lack of definition. Apparently it seems that some soil will be removed close to the wall to allow water flow towards Lot 29 or Lot 27 through the wall. In any case, there is missing information about land height:

- Detail of the land height in the area close to Lot 29: What will be the slope towards Lot 27 (northwest corner ie. area A in figure 8)? Will it be lower than the point where there is no wall (Lot 25 ie. Area B in figure 8)?
- Detail of the land height in the area close to Lot 27: Will the water from the popup emitter flow again towards Lot 27?

- The only way that water may find to flow towards Lot 29 is through the wall, and consequently only filtered water through the ground will make it. The flow of water through filtered soil is significantly less than the flow at the surface, so only a little amount of the water will be filtered and most of it will flow on the surface. Since the proposal is undefined, *the only efficient solution is to remove the soil at a lower level than the shown in photo#1 of figure 1 (where the wall ends) and make proper drainage holes in the wall. Otherwise, the water will accumulate and will flow again under the fence where there is no wall and it is currently the lowest point in Lot 26 (area B).*

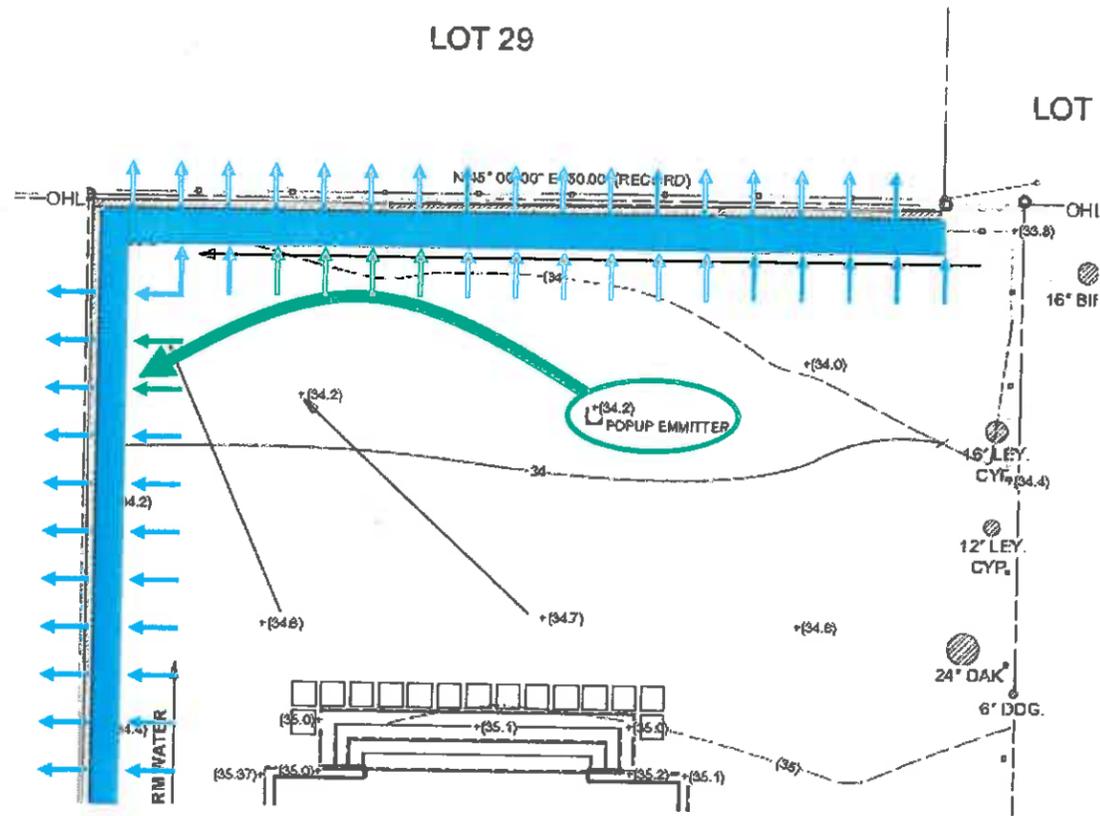
Figure 11: Alternative 1 floor drawing

The popup emitter that brings the water from the roof should be moved to a place where the water only could pour to Lot 27, according to the previous situation (figure 11) to avoid increase the amount of water flowing to Lot 29.

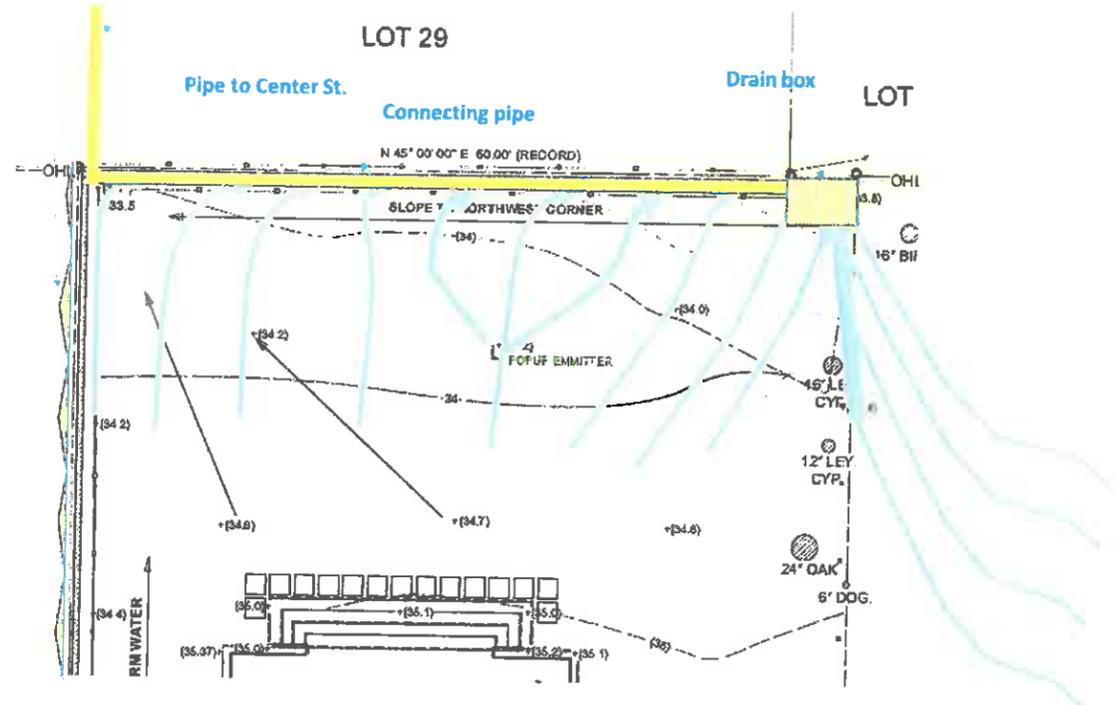
Figure 13: Alternative 2 floor drawing

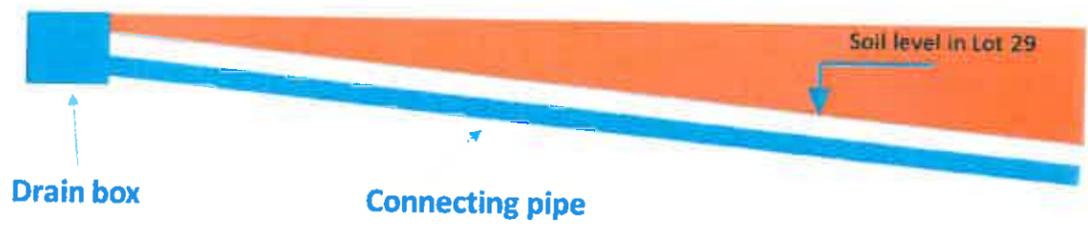
Figure 14: Alternative 2 wall longitudinal profile

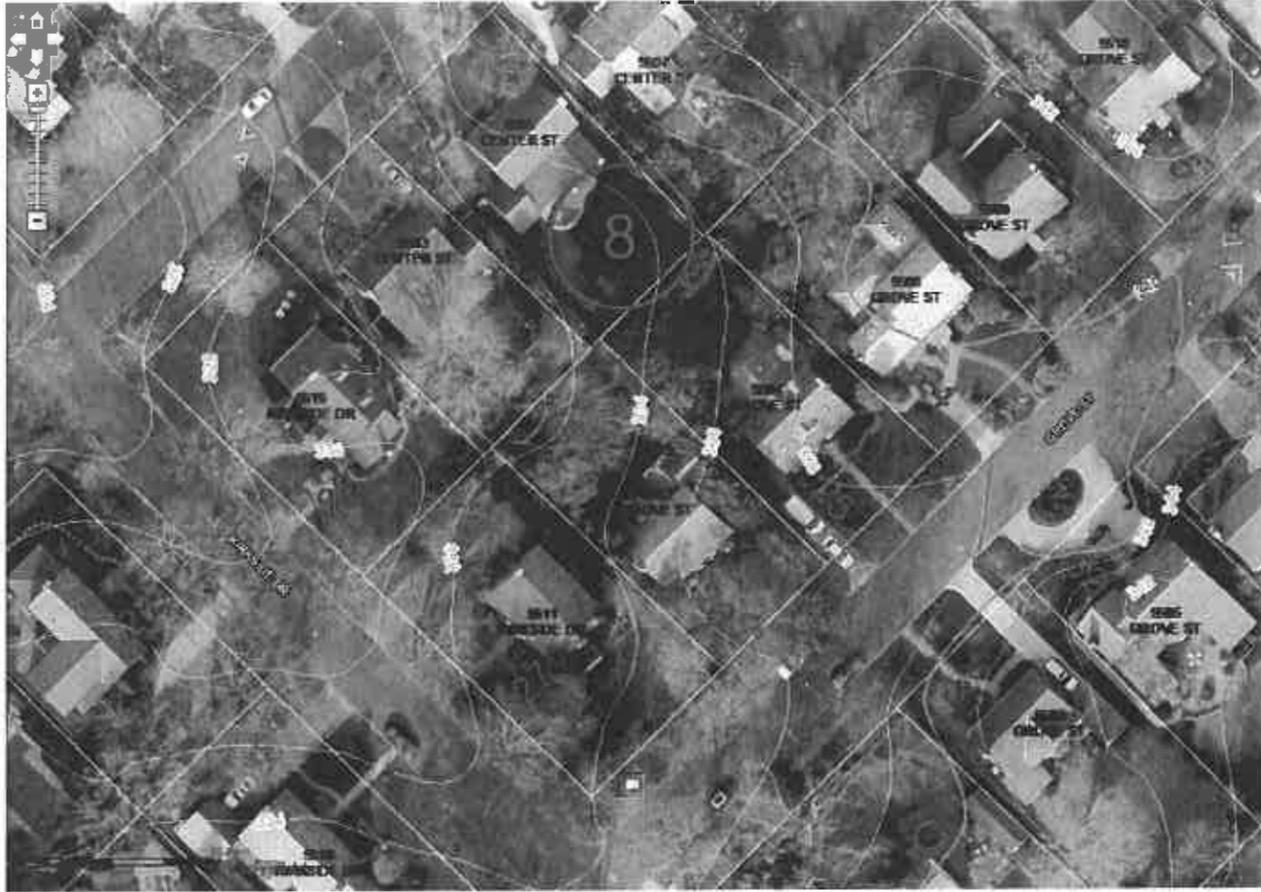
Aerial Photo from MCAtlas website. Lot Numbers in red. Photo taken prior to construction. Subject Property is Lot 26.

Based on the plans provided to us, the pre-construction storm water runoff for the subject property (Lot 26) drained from the front right to the rear left of the property. (All references to locations on a property such as front, back, right and left are based on a person standing in the street in front of the noted property and looking at the house.) This drainage pattern also directs water from the adjacent properties at 5504 and 5506 Grove Street to both the subject property and to 5503 Center Street, as can be seen on GIS topographic data available for Montgomery County.

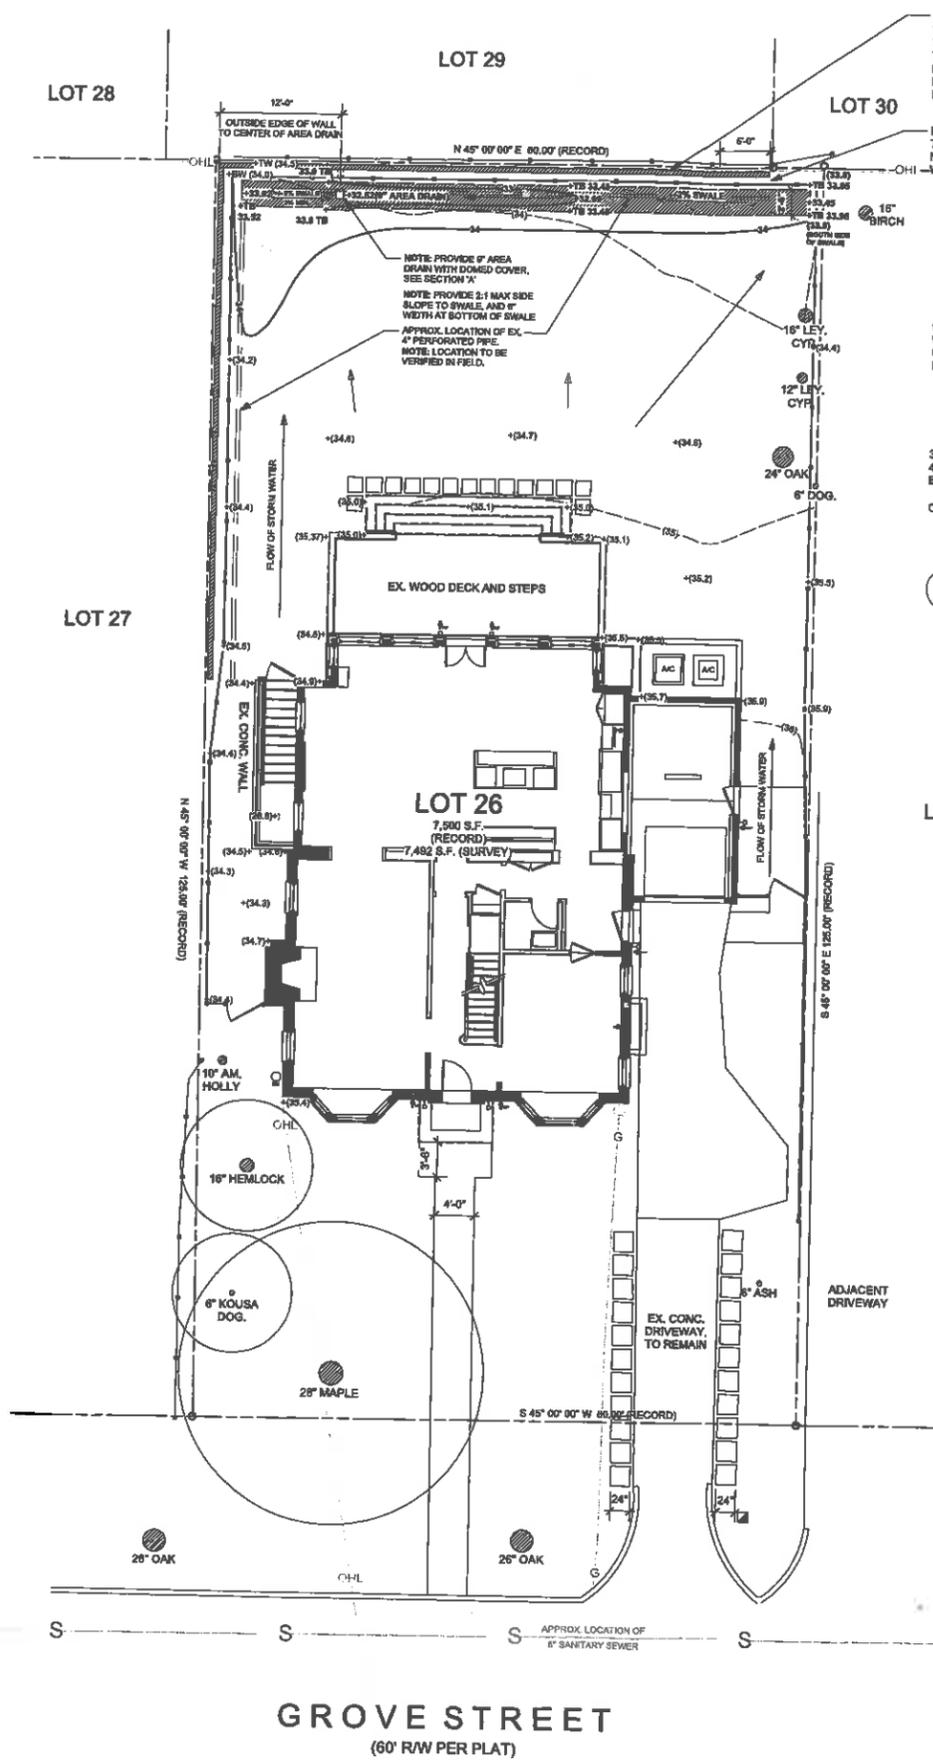
Final Proposed Plan

NOTE: 1/2" DIA. WEEP HOLES TO BE DRILLED INTO THE TOP TIER AND BOTTOM TWO TIERS ON NORTH SIDE OF WOOD TIE WALL, SPACED AT 2'-0" O.C., AT THE MIDPOINT OF THE TIMBERS. WHEN DRILLING THE WEEP HOLES, PIERCE THE MIRA DRAIN FABRIC TO ENSURE THAT WATER IS ABLE TO PASS THROUGH IT AND THE WEEP HOLES. ALSO, PIERCE FABRIC WHERE THERE IS A GAP IN THE TIMBERS.

NOTE: G.C. TO CAP EX. 4" PERFORATED PIPE BEHIND WOOD TIE WALL AND REMOVE 5'-0" LENGTH OF GRAVEL BEHIND THE NORTH EAST END OF THE WOOD TIE WALL. REPLACE GRAVEL WITH SUBSOIL.

NOTE: PROVIDE 2:1 MAX SIDE SLOPE TO SWALE, AND 8" WIDTH AT BOTTOM OF SWALE.

APPROX. LOCATION OF EX. 4" PERFORATED PIPE. NOTE: LOCATION TO BE VERIFIED IN FIELD.
