**Chevy Chase Village
Board of Managers**

**APPEAL NUMBER A-6895—CONTINUED
MR. CHRISTOPHER IAN AND MS. VICTORIA TWINN
OF 5503 CENTER STREET &
MR. DAVID AND MS. JULIA LEE
OF 5505 CENTER STREET
CHEVY CHASE, MARYLAND 20815**

ADDENDUM TO REPORT DATED OCTOBER 14, 2016

DRAINAGE REPORT FOR 5502 GROVE STREET IN CHEVY CHASE, MARYLAND

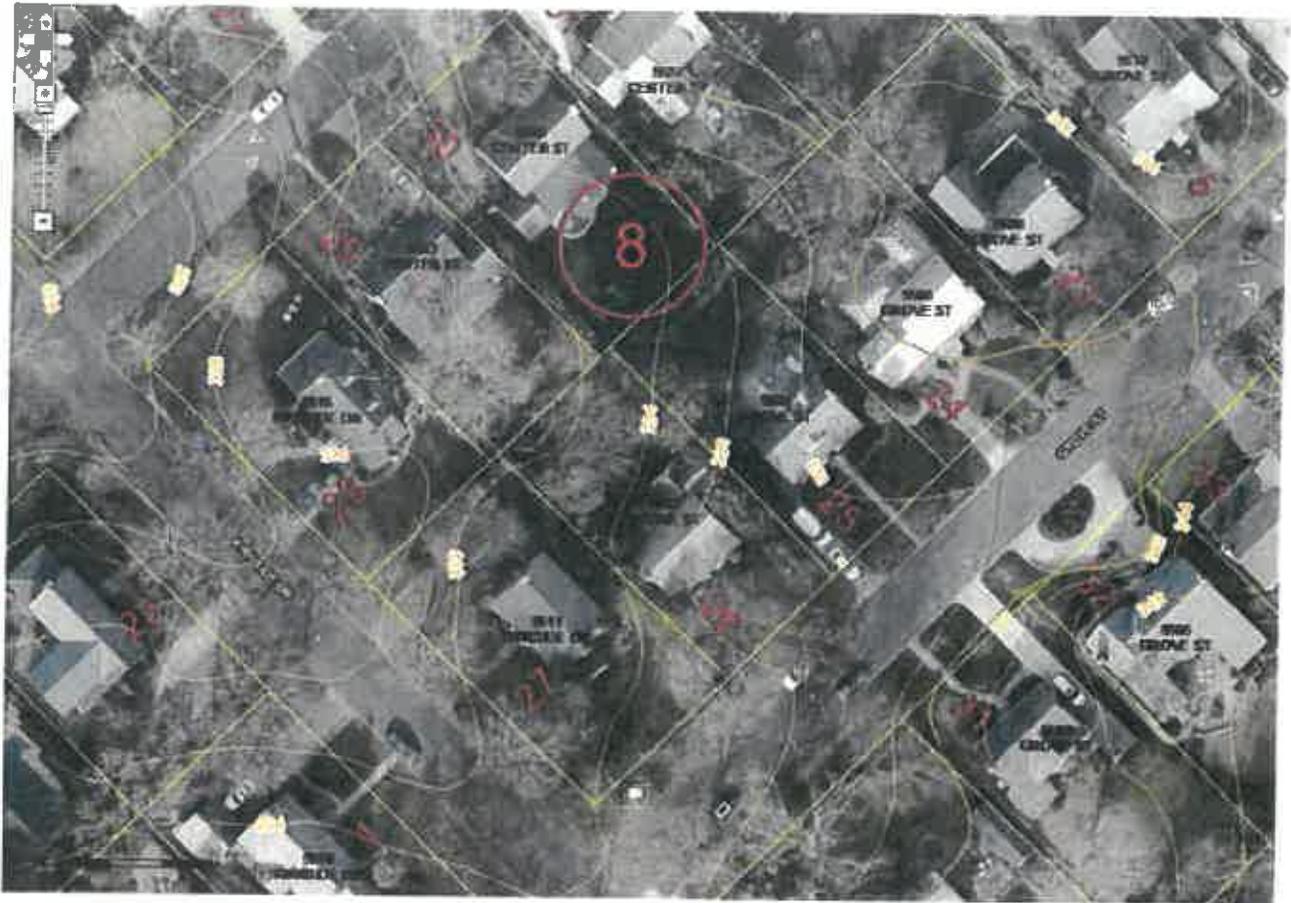
Aerial Photo from MCAtlas website. Lot Numbers in red. Photo taken prior to construction. Subject Property is Lot 26.

Based on the plans provided to us, the pre-construction storm water runoff for the subject property (Lot 26) drained from the front right to the rear left of the property. (All references to locations on a property such as front, back, right and left are based on a person standing in the street in front of the noted property and looking at the house.) This drainage pattern also directs water from the adjacent properties at 5504 and 5506 Grove Street to both the subject property and to 5503 Center Street, as can be seen on GIS topographic data available for Montgomery County.
