**Chevy Chase Village  
Board of Managers**

## **Case A-6895-continued**

## **ADDENDUM TO REPORT DATED OCTOBER 14, 2016**

## **DRAINAGE REPORT FOR 5502 GROVE STREET IN CHEVY CHASE, MARYLAND**

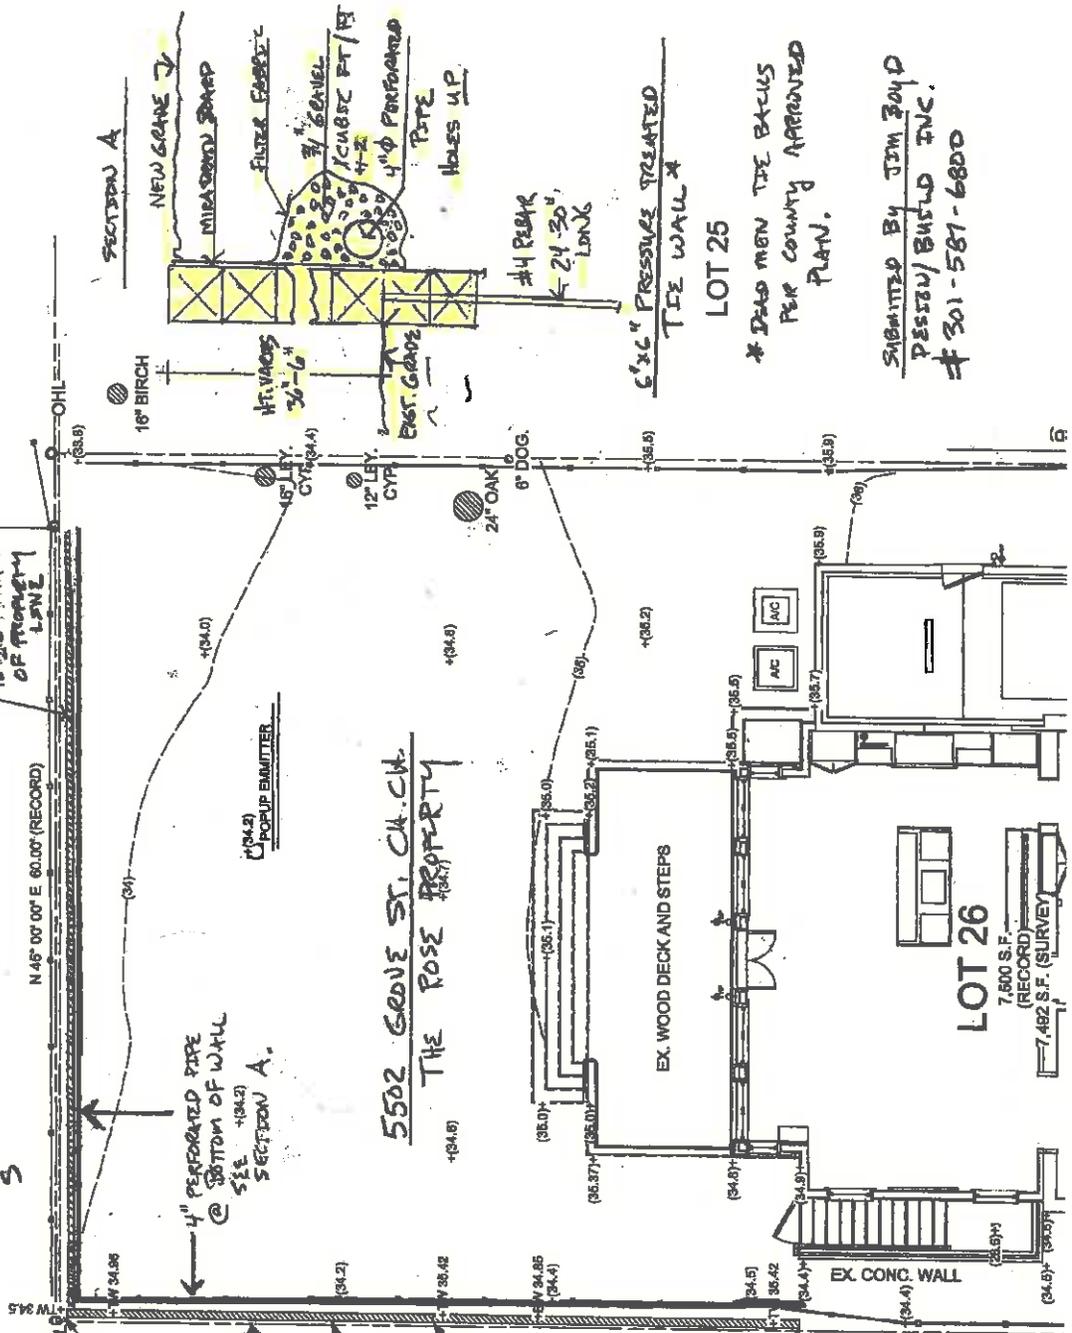
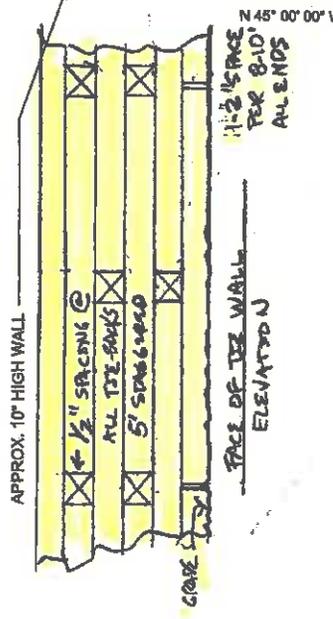
ROSE RESIDENCE  
5502 GROVE STREET, CHEVY CHASE, MD 20815

BACK OF WALL IS 3'-6\"/>

★ SEE FACE OF TIE WALL ELEVATION BELOW.

NOTE: WALL STEPS DOWN 5.5'

EX. CONC. WALL

\* DEDICATED TIE BACKS PER COUNTY APPROVED PLAN.
